PACIFIC SCIENTIFIC

SERVICE BULLETIN

PASSENGER / CREW 90° RELEASE
LAP BELT BUCKLE ASSEMBLY

SERVICE BULLETIN NUMBER
1108460-25-01

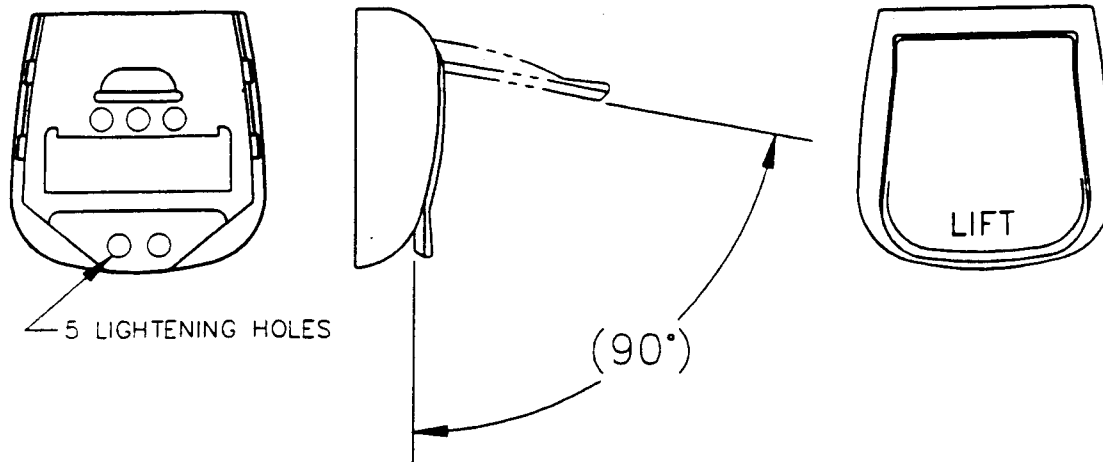
FIGURE 1

- 1) Inspect the crew restraint system or the lap belt assembly in which an 1108460 buckle is installed. The buckle can be easily identified by the lift lever characteristic, but more so by the composite plastic components which enclose the metal load carrying members of the buckle. The existing buckle design, which must be replaced, has a total of five lightening holes in the bottom frame surface. The retrofit buckle will only have two lightening holes (towards the back portion of the frame, opposite from where the plug-in connector inserts into the buckle). The retrofit buckle will also have an identification marking indent stamped on the bottom surface, which represents the frame detail part number 1108556. See Figure 1 and 2 for reference.

IDENTIFY EXISTING 1108460 BUCKLES BY COUNTING THE FIVE LIGHTENING HOLES IN BOTTOM SURFACE OF FRAME

- 2) The restraint system or the affected lap belt shall be removed from the aircraft in accordance with the applicable maintenance manual.
- 3) Return the restraint system or affected lap belt to Pacific Scientific for retrofit of the buckle. The required repair or replacement of the buckle shall only be performed by Pacific Scientific Company.

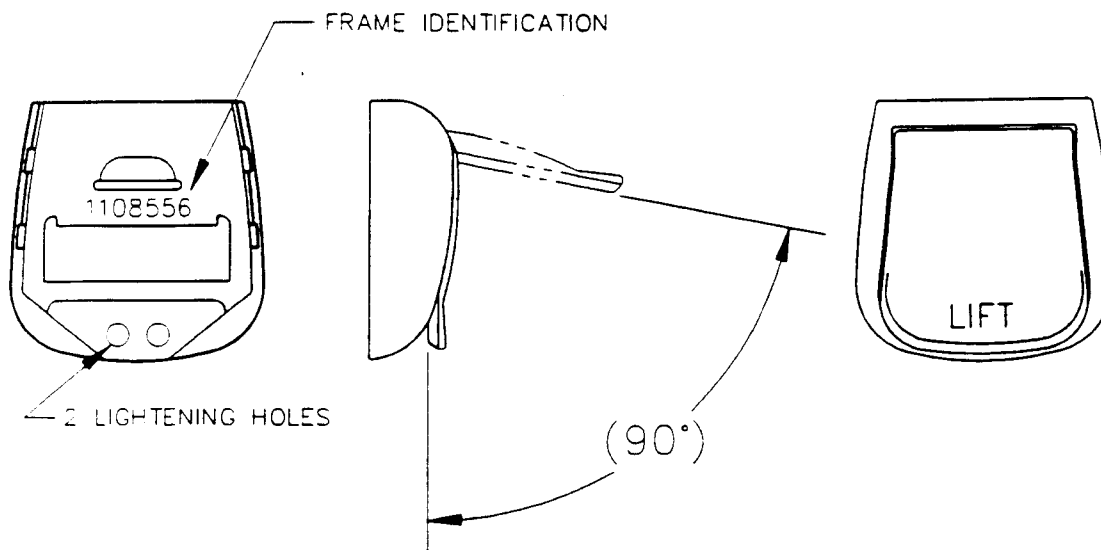
FIGURE 2

NOTE: *For purposes of inspection and future reference, the markings on the bottom surface of the buckle (1108556) and the reduction in the number of lightening holes (two towards the back of the frame) shall be the method of identification for compliance with this Service Bulletin. In addition to the buckle identification, the identification label of each lap belt assembly incorporating a lift lever buckle, shall have an "M" included in the basic part number.*

UPGRADED 1108460M BUCKLE DESIGN HAS AN IDENTIFICATION MARKING AND TWO LIGHTENING HOLES IN THE BOTTOM SURFACE OF FRAME
