PACIFIC SCIENTIFIC

SERVICE BULLETIN

**PASSENGER / CREW 45° RELEASE
LAP BELT BUCKLE ASSEMBLY**

SERVICE BULLETIN NUMBER
1108435-25-01

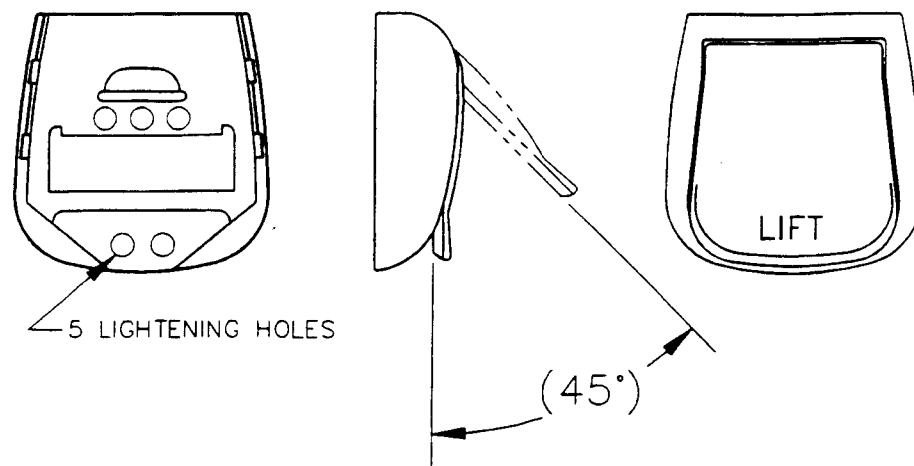
FIGURE 1

lever characteristic, but more so by the composite plastic components which enclose the metal load carrying members of the buckle. The existing buckle design, which must be replaced, has a total of five lightening holes in the bottom frame surface. The replacement buckle will only have two lightening holes (towards the back portion of the frame, opposite from where the plug-in connector inserts into the buckle). The replacement buckle will also have an identification marking indent stamped on the bottom surface, which represents the frame detail part number 1108556. See Figure 1 and 2 for reference.

IDENTIFY EXISTING 1108435 BUCKLES BY COUNTING THE FIVE LIGHTENING HOLES IN BOTTOM SURFACE OF FRAME

- 2) The restraint system or the affected lap belt shall be removed from the aircraft in accordance with the applicable maintenance manual.
- 3) Return the restraint system or affected lap belt to Pacific Scientific for rework or replacement of the buckle. The required replacement or repair of the buckle shall only be performed by Pacific Scientific Company.
- 4) Re-install the replacement lap belt or restraint system in accordance with the applicable maintenance manual.

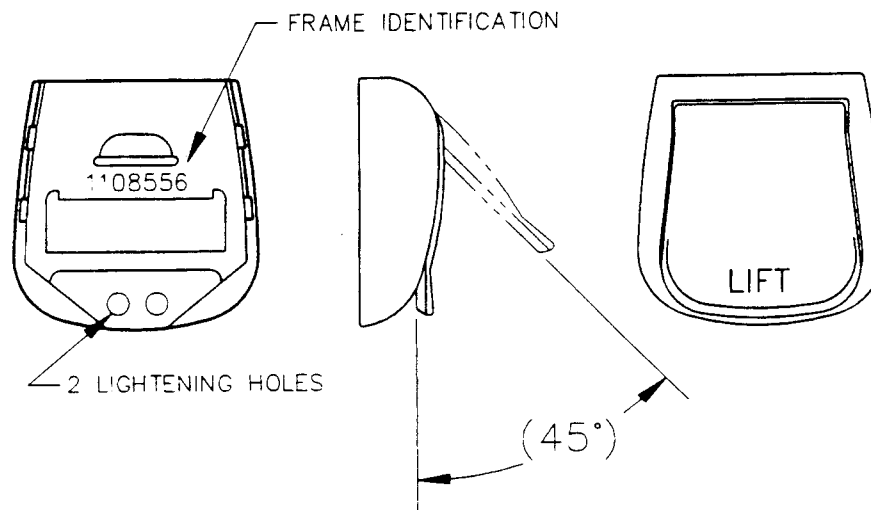
FIGURE 2

NOTE: *For purposes of inspection and future reference, the markings on the bottom surface of the buckle (1108556) and the reduction in the number of lightening holes (two towards the back of the frame) shall be the method of identification for compliance with this Service Bulletin. In addition to the buckle identification, the identification label of each lap belt assembly incorporating a lift lever buckle, shall have an "M" included in the basic part number.*

UPGRADED 1108435M BUCKLE DESIGN HAS AN IDENTIFICATION MARKING AND TWO LIGHTENING HOLES IN THE BOTTOM SURFACE OF FRAME
